AFML-TR-78-160
Volume II

COST EFFECTIVE REPAIR TECHNIQUES FOR TURBINE AIRFOILS

GENERAL ELECTRIC COMPANY

APRIL 1979

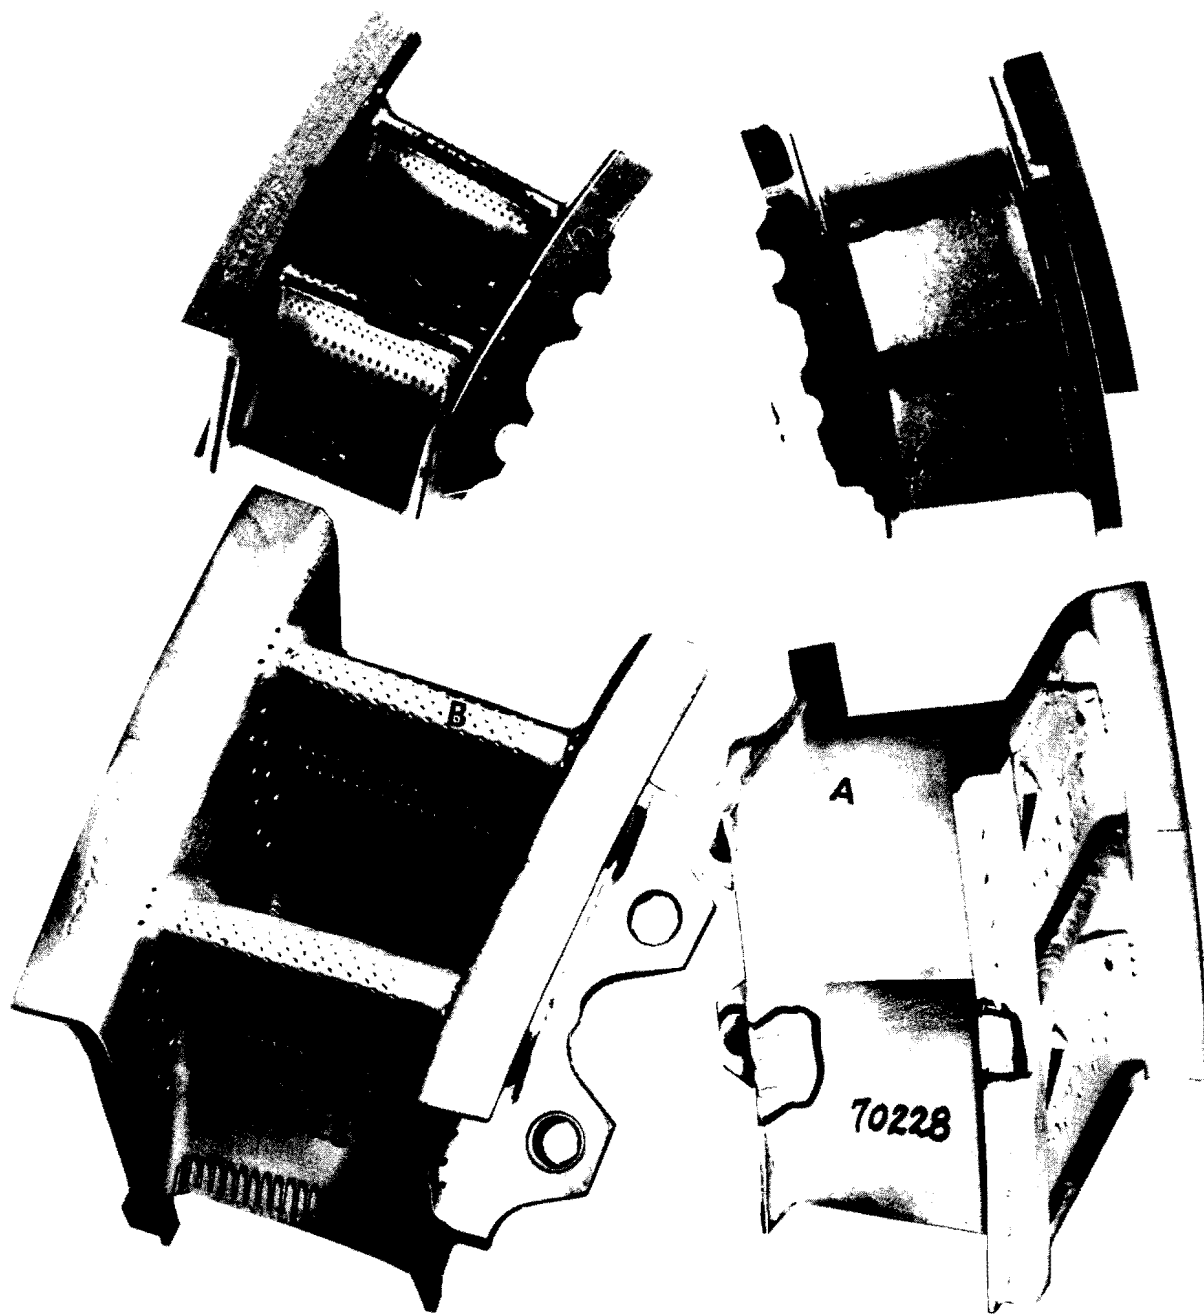
Three Stage 1 vanes were chosen for metallographic evaluation as indicated previously. Figure 2 shows S/N 70228 as it appeared before ADH repair and then after engine test. (In all macrophotographs, the before repair condition is at the top and the repaired engine run condition at the bottom.) Area A is shown as a repair on the convex surface of the lead vane and both visual and metallographic examination (Figure 3) shows this repair as successful. Area B was typical of the repair performed at the lead edge nose holes with the resultant cracking shown in Figure 4. This figure also shows the cracking which initiated in the ADH repair in Area C at the trail edge of the lead vane. Figure 5 again illustrates cracking which occurred in the ADH repair and Figure 6 shows that crack propagation followed the ADH alloy exclusively. Figure 7 shows successful repairs at the trail edge of the lead vane and above the trail edge cooling holes on the trail vane as well as the unsuccessful repair on both vanes at the leading edge. Nearly all repairs attempted on the aft side of both inner and outer platform areas on all twelve vanes were unsuccessful.

Figure 2. Stage 1 HPTV, S/N 70228, Before ADH Repair and After 1000 Cycle Engine Test

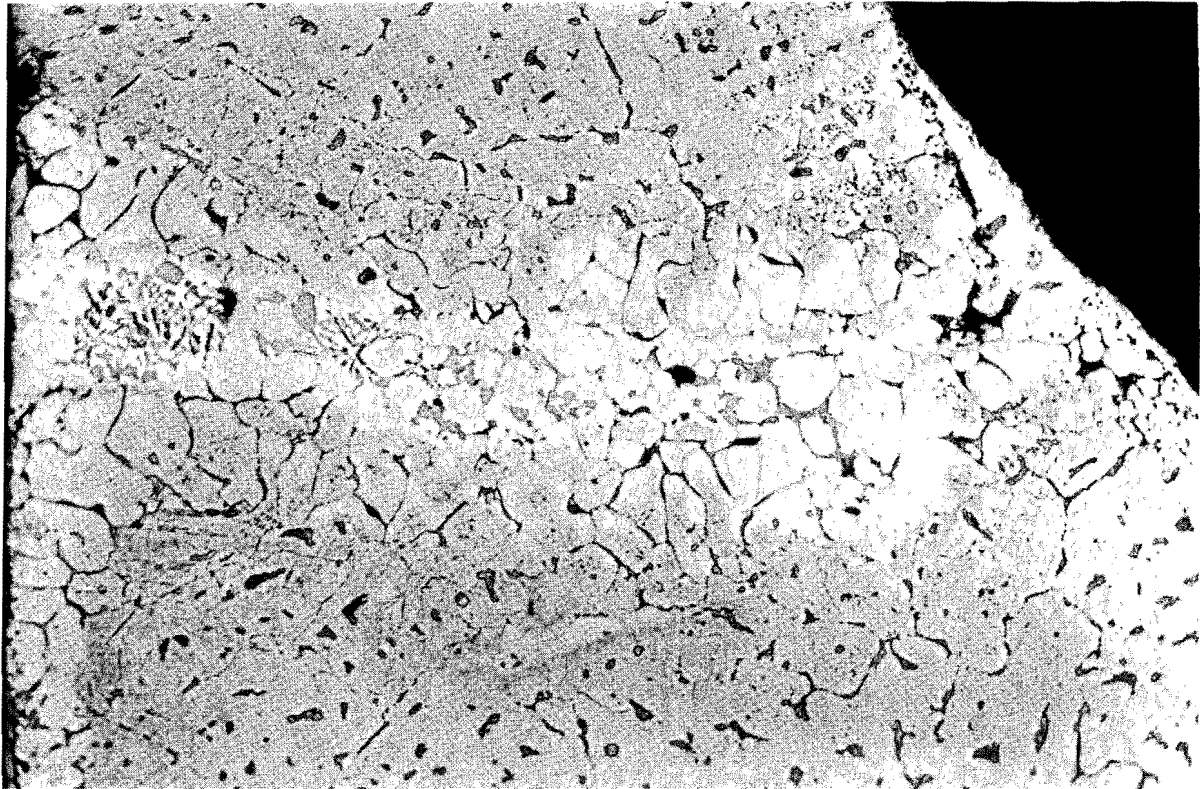
Figure 3. Photomicrograph in Area A on Stage 1 HPTV, S/N 70228
Showing Successful ADH Repair After Engine Test

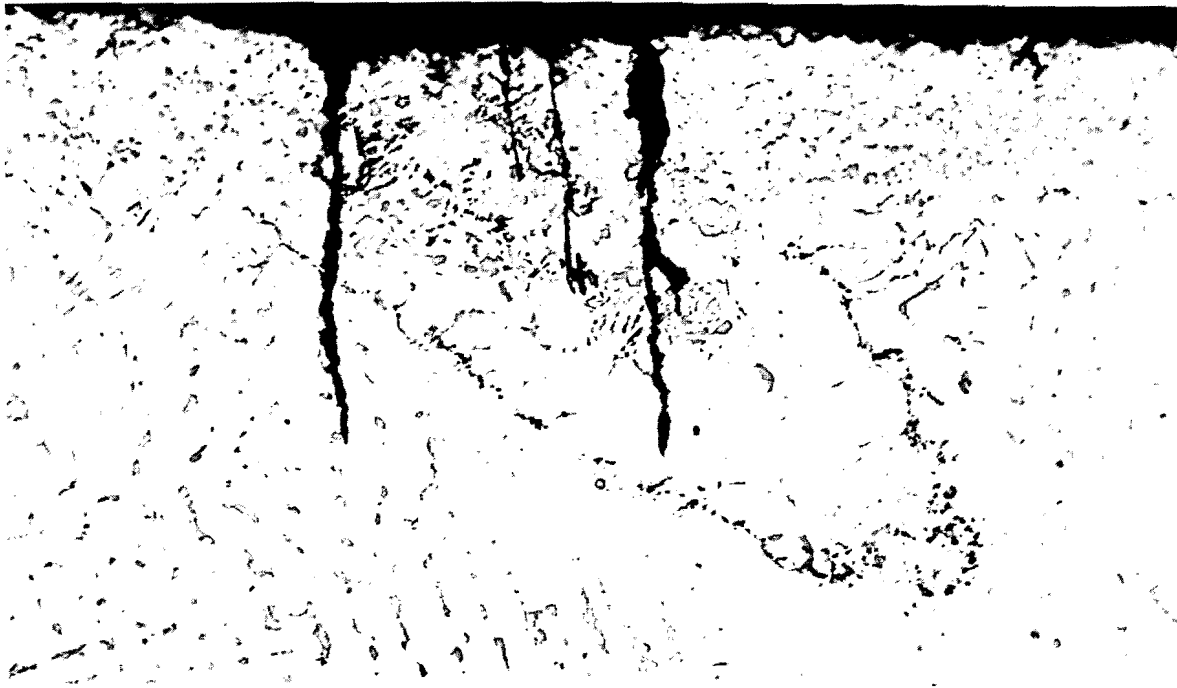
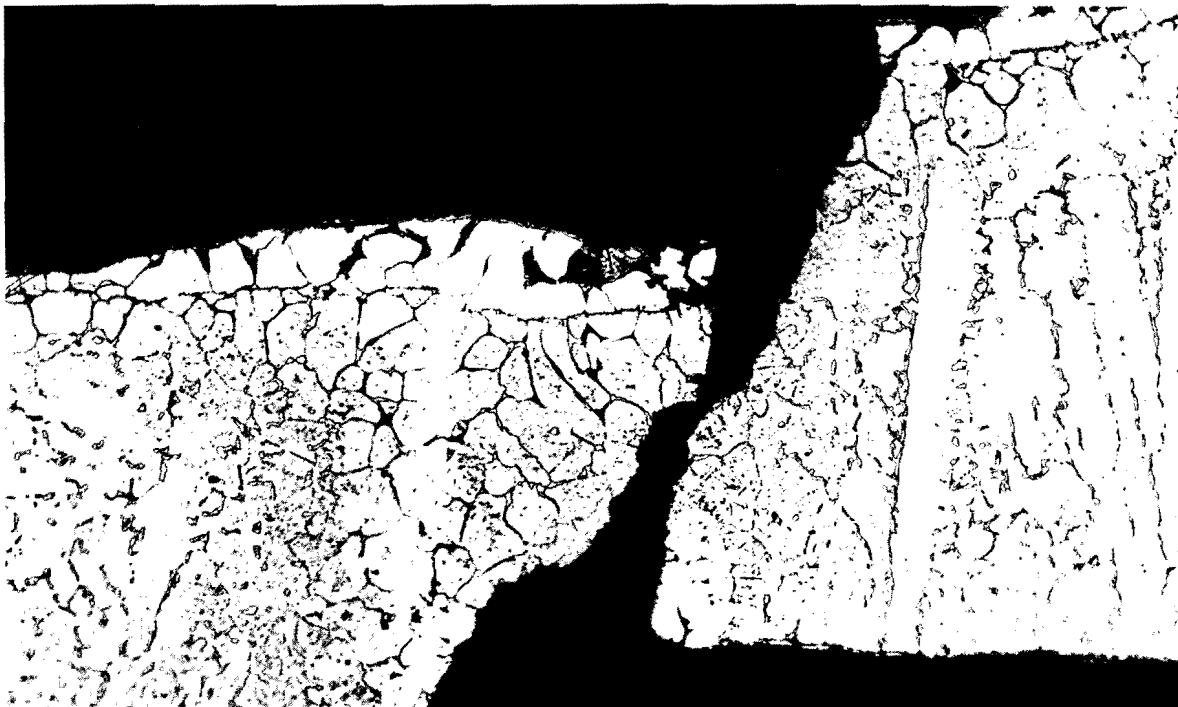
Figure 4. Microsection Through ADH Repair on Stage 1 HPTV, S/N 70228, Showing Engine Induced Cracking in Areas B (upper) and C (lower)

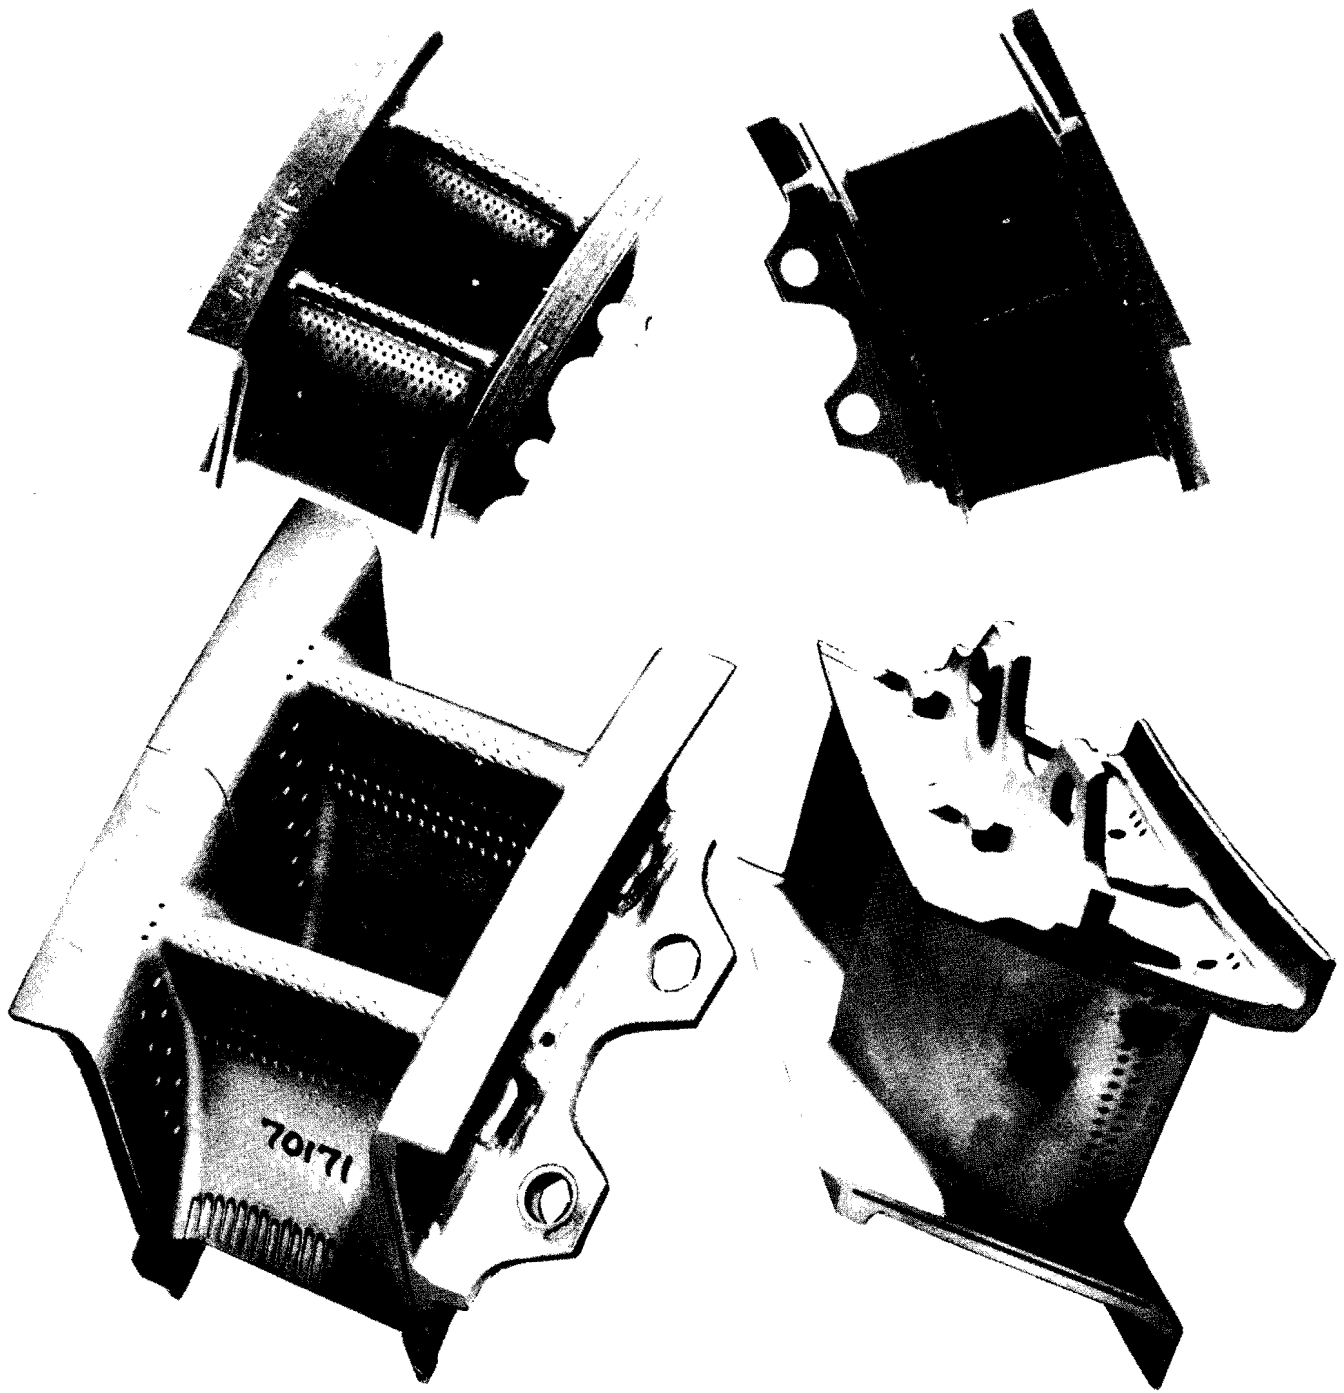
Figure 5. Stage 1 HPTV, S/N 70171, Before ADH Repair and After 1000 Cycle Engine Test Showing Area Examined Metallographically

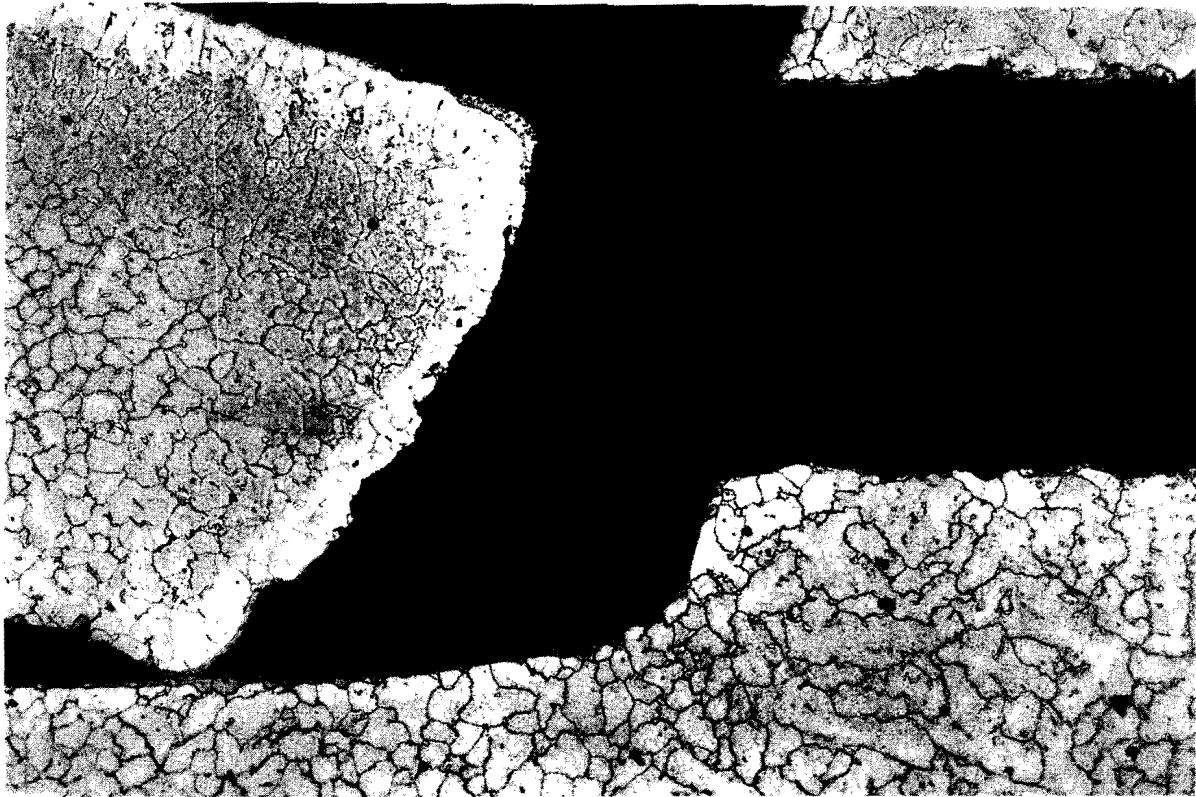
Figure 6. Photomicrograph of Section in Area A on Stage 1 HPTV, S/N 70171, Showing Engine Induced Failure Through ADH Alloy and Repair

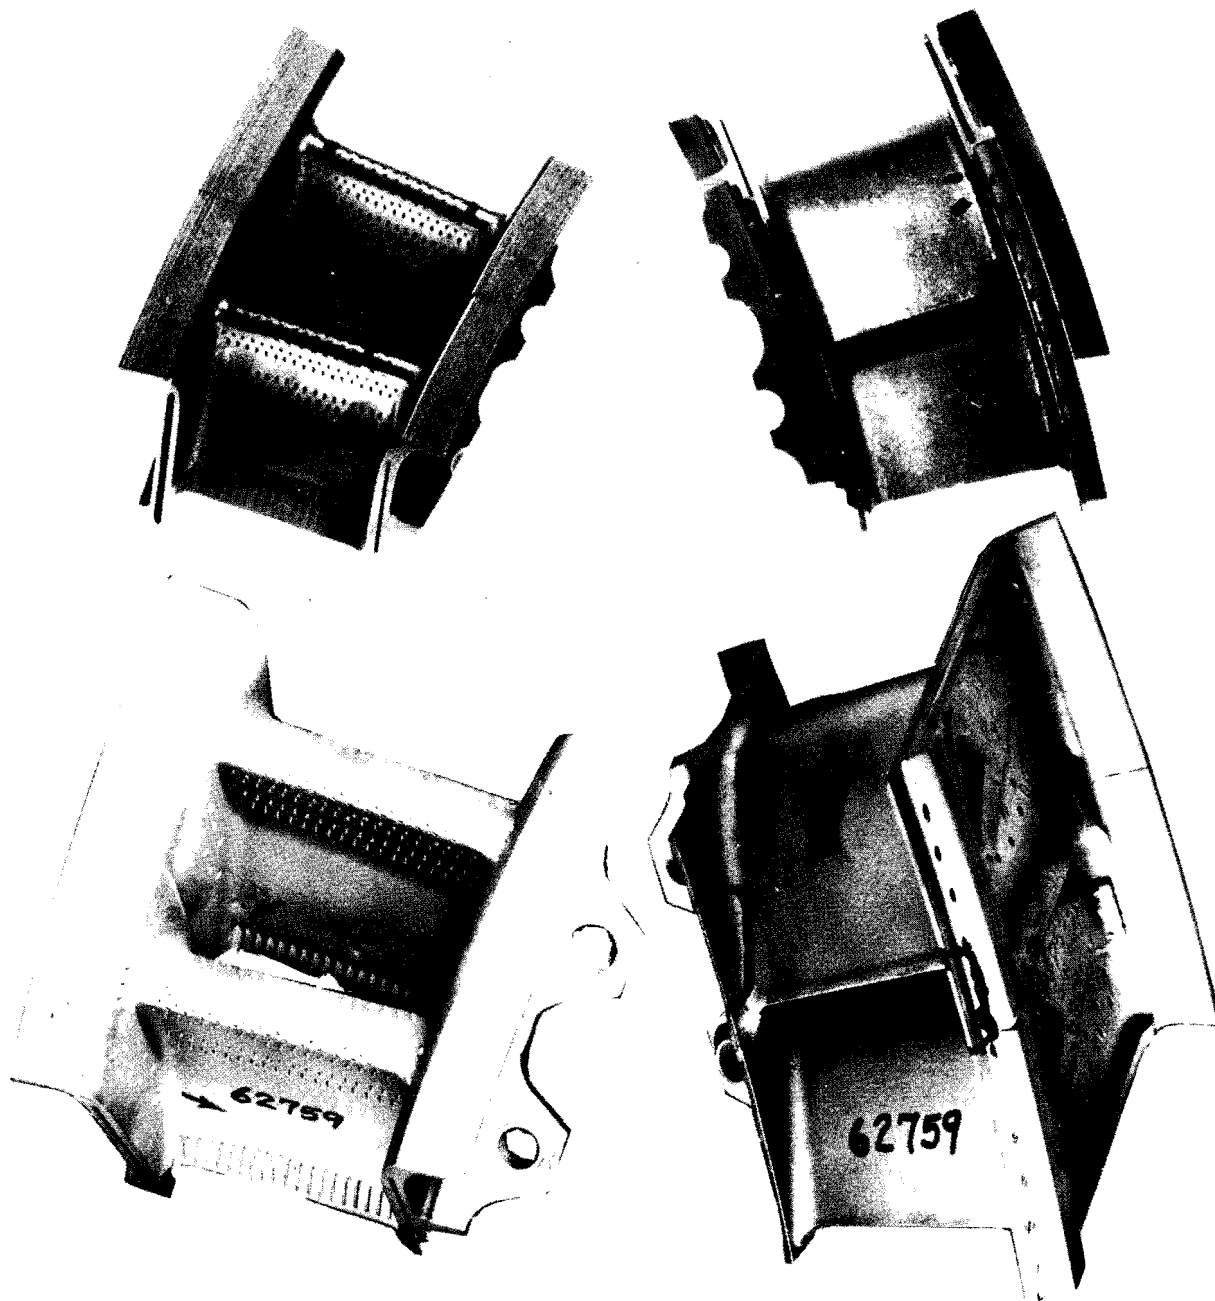
Figure 7. Stage 1 HPTV, S/N 62759, Before ADH Repair and After 1000 Cycle Engine Test Showing Successful ADH Repair

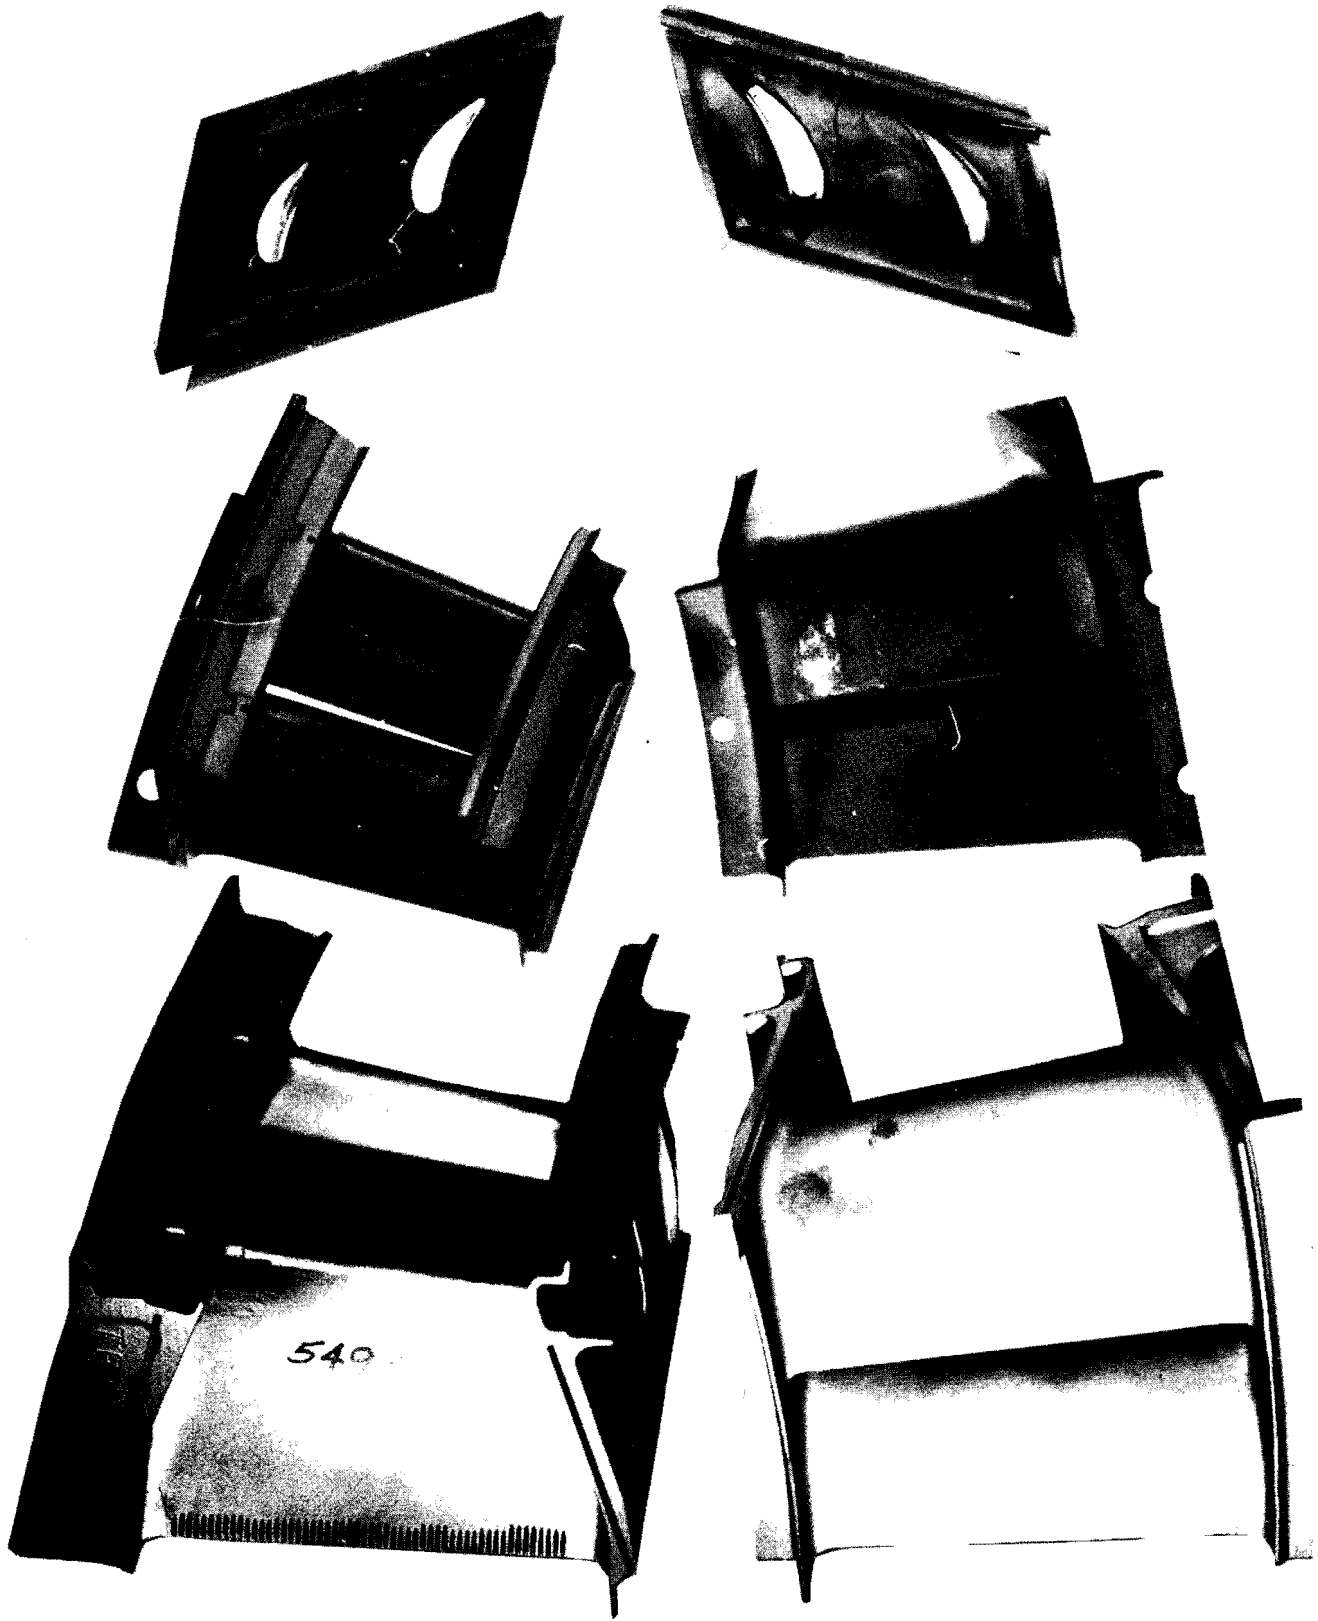
Figure 8. Stage 2 HPTV, S/N 54954, Before ADH Repair and After 1000 Cycle Engine Test Showing Areas Examined Metallographically

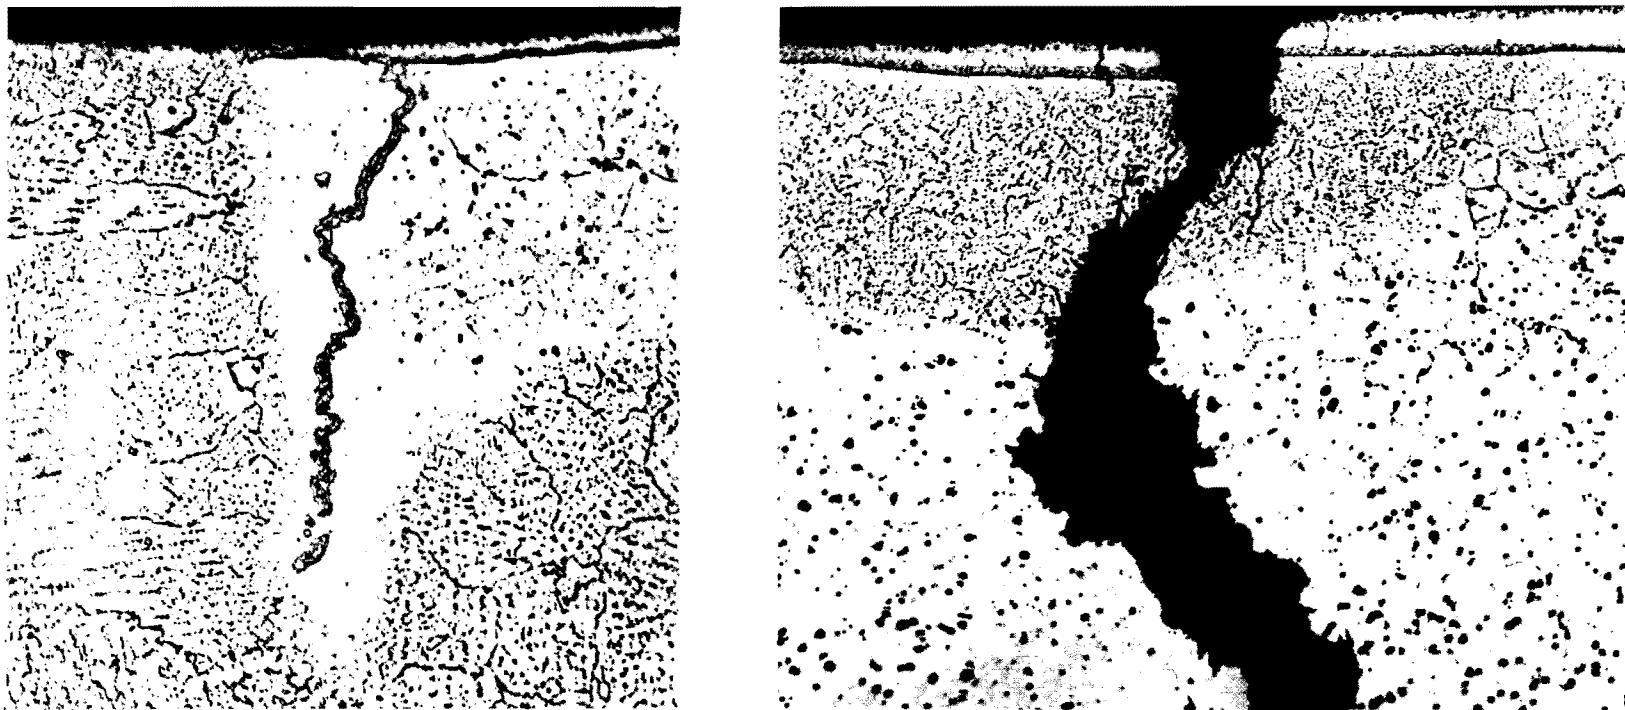
LEFT: SUCCESSFUL ADH REPAIR OF PRIOR WELD CRACK IN AREA A
RIGHT: ENGINE INDUCED CRACK OF WELD REPAIR IN AREA B

Figure 9. Microphotographs of Sections From Area A and B of Stage 2 HPTV, S/N 54954
After 1000 Cycles Engine Test

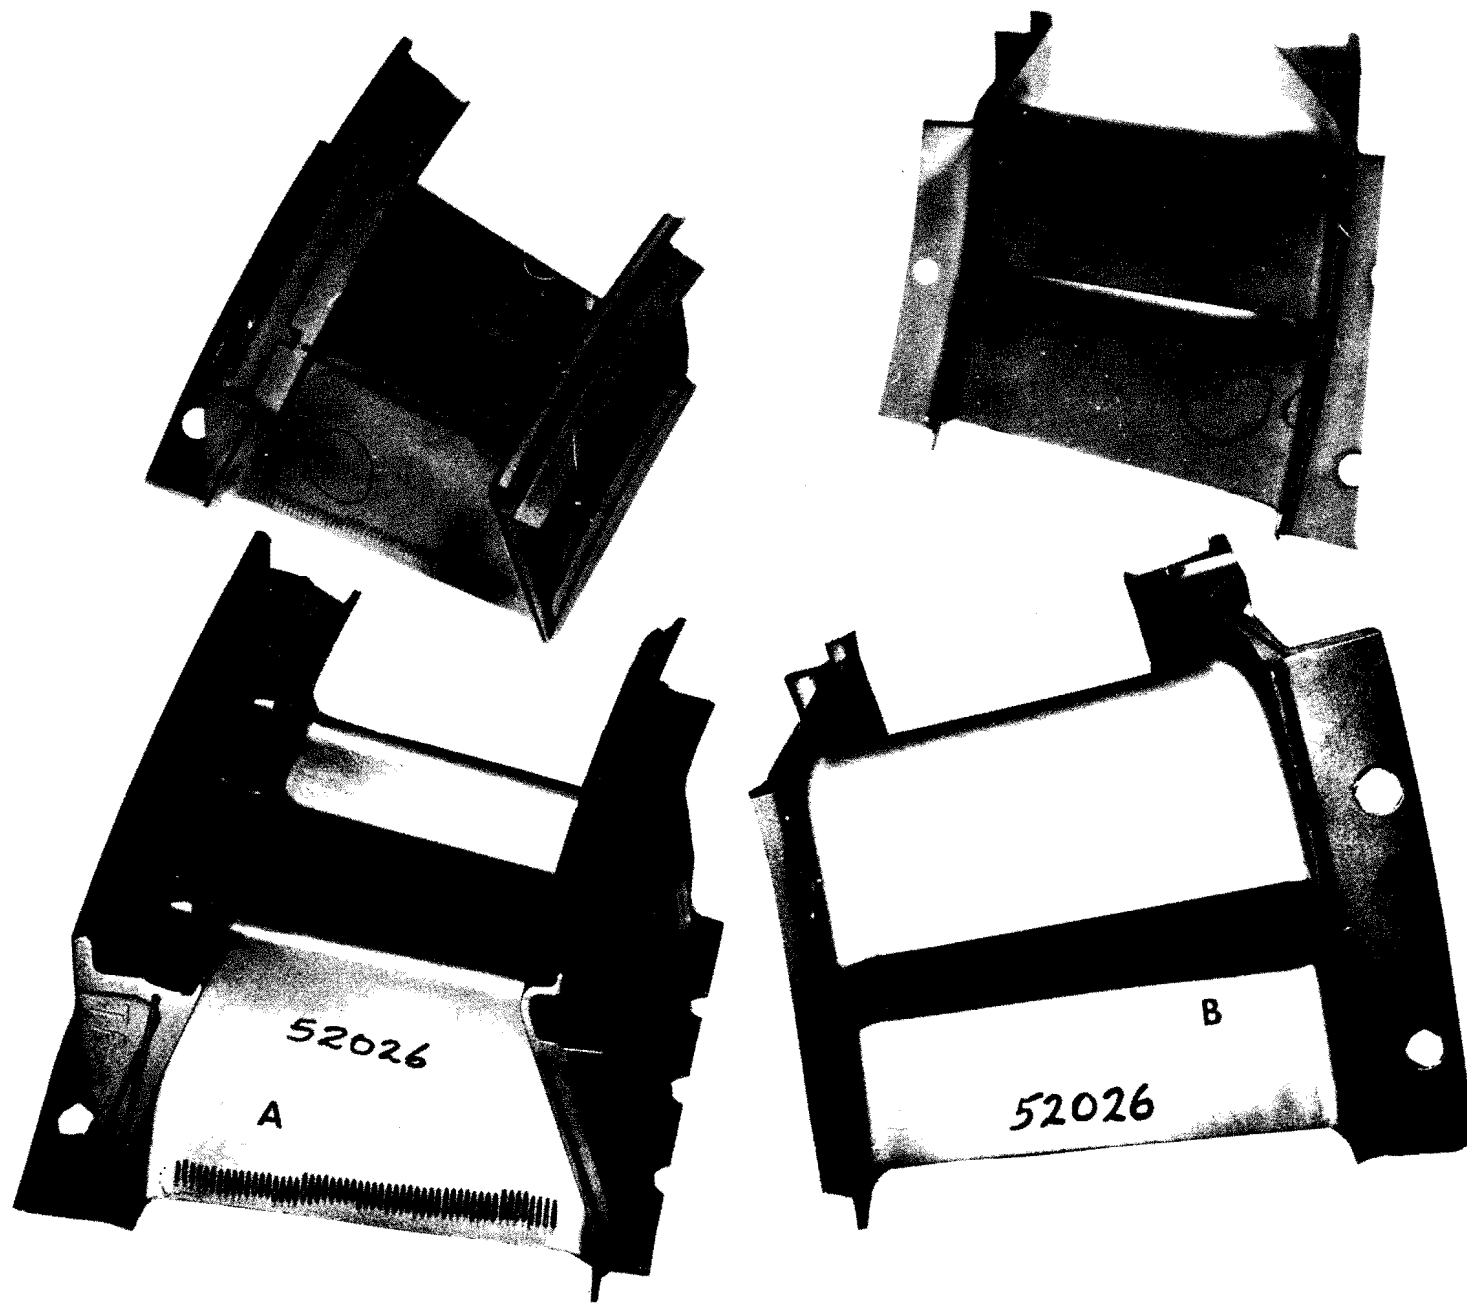
Figure 10. Stage 2 HPTV, S/N 52026, Before ADH Repair and After 1000 Cycle Engine Test. Areas A and B Examined Metallographically.

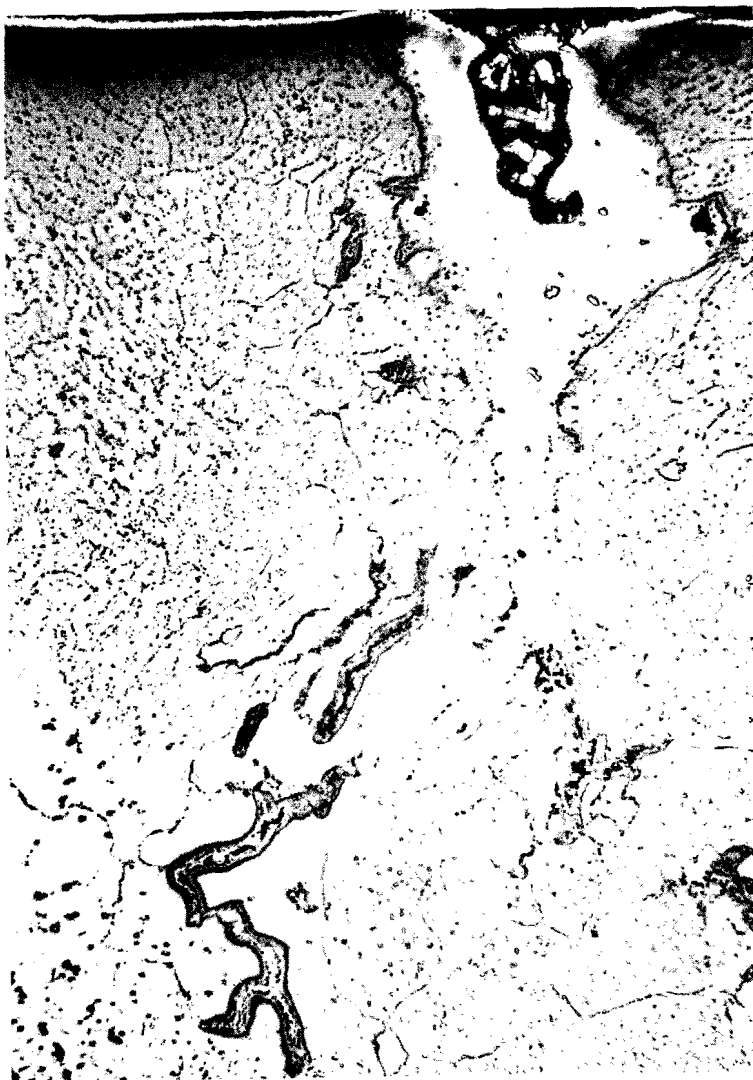
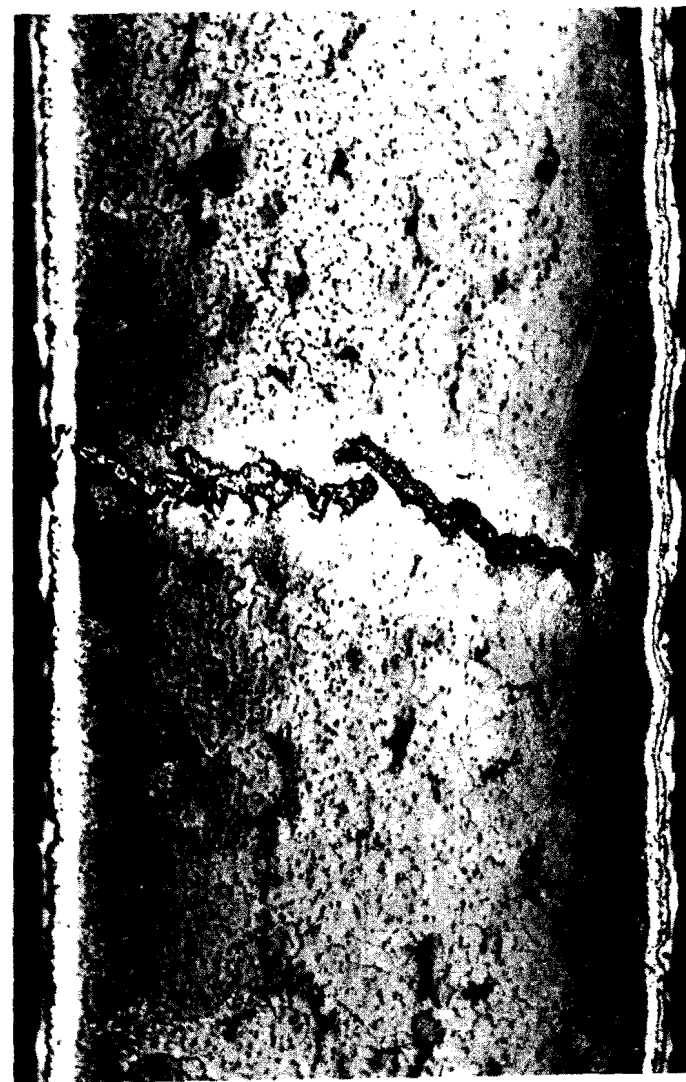
LEFT: SECTION OF AREA B SHOWING SUCCESSFUL ADH REPAIR OF CRACKED
WELD REPAIR

RIGHT: SECTION OF AREA A SHOWING SUCCESSFUL ADH AIRFOIL REPAIR

Figure 11. ADH Repair on Stage 2 HPTV, S/N 52026, After 1000 Cycle Engine Test

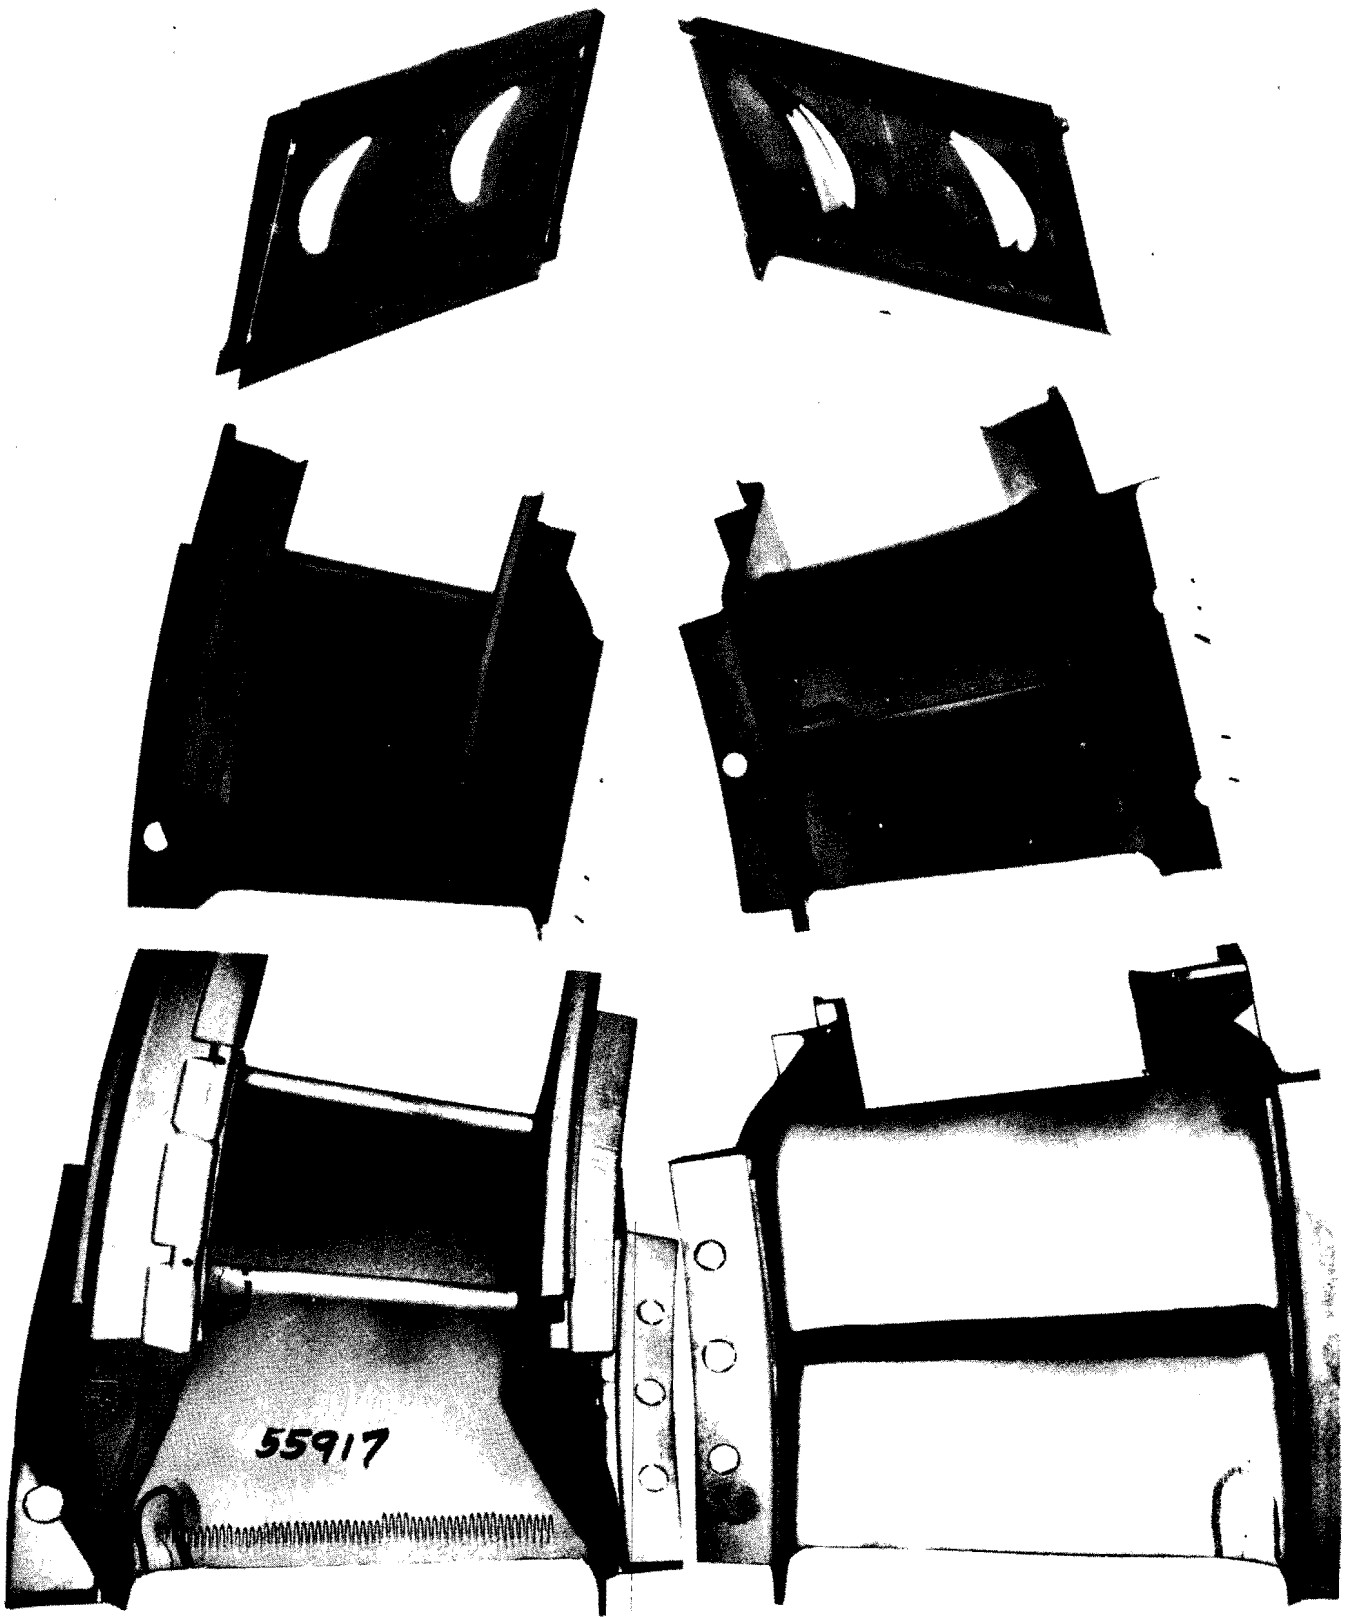
Figure 12. Stage 2 HPTV, S/N 55917, Before ADH Repair and After 1000 Cycle Engine Test

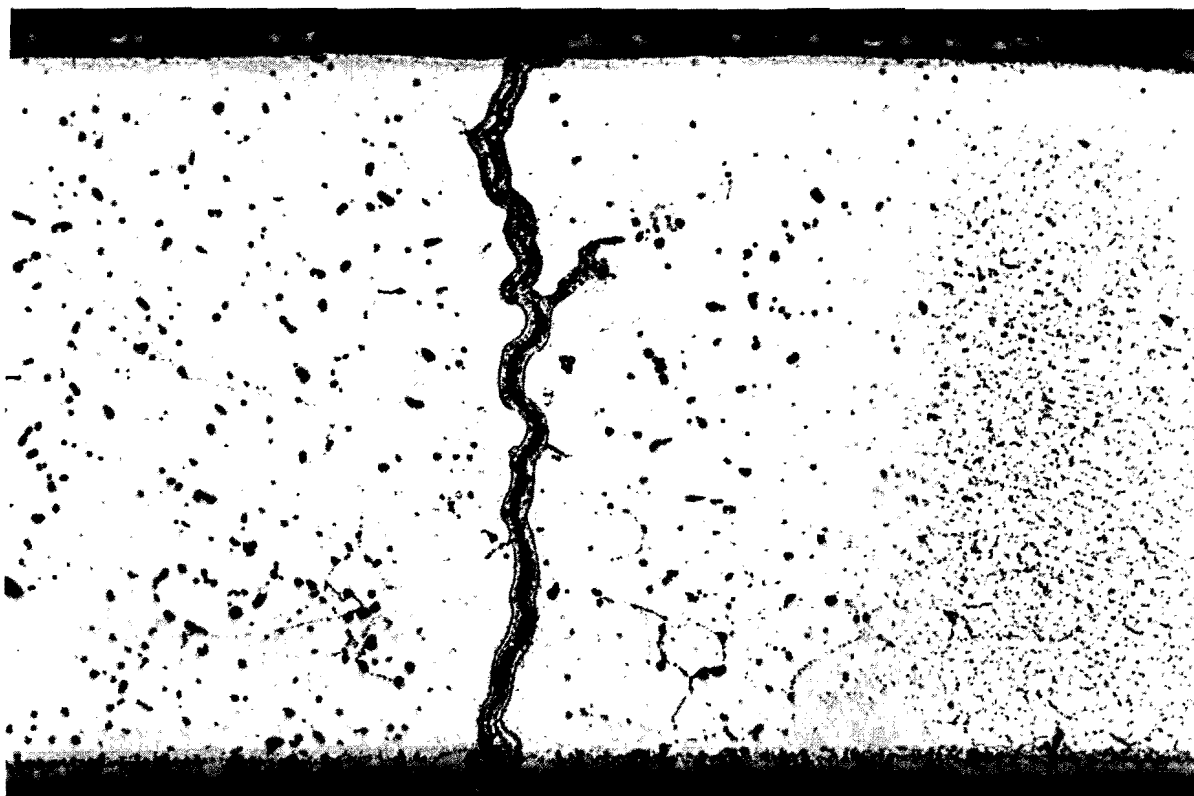
Figure 13. Incomplete ADH Repair on Outer Platform Stage 2 HPTV, S/N 55917,
After 1000 Cycle Engine Test

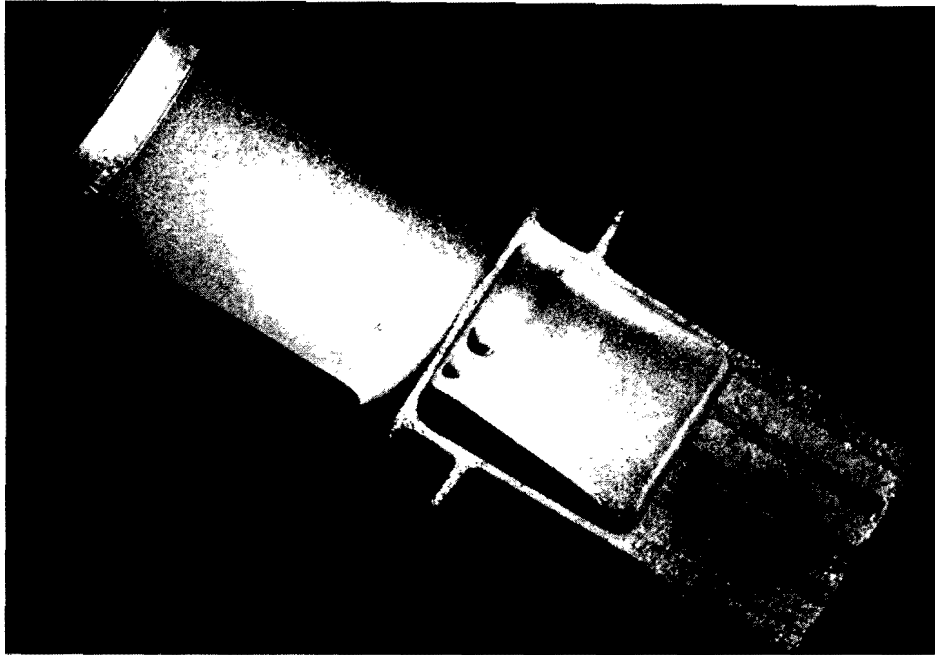
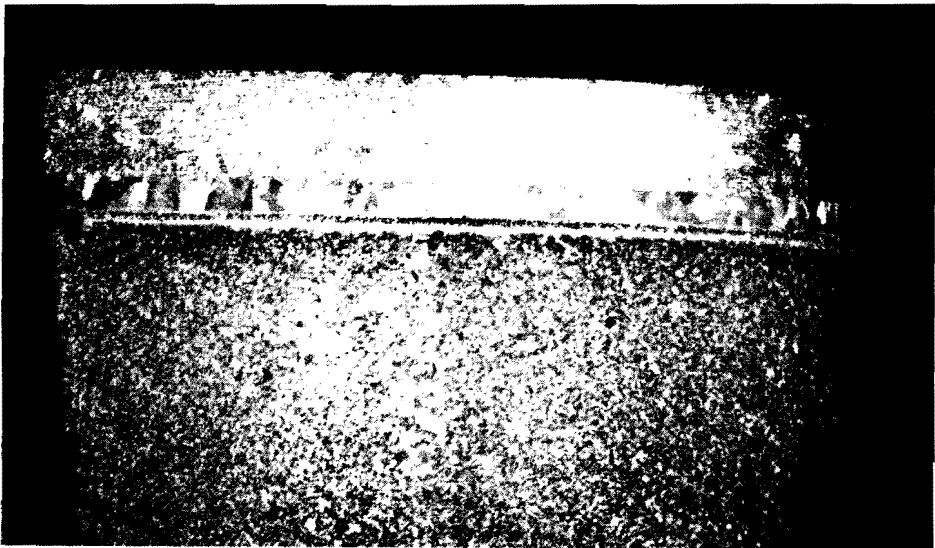
Figure 14. Stage 1 HPTB Showing Furnace ADB of Rene' 80 Tip Cap and HS 188 Squealer Tip

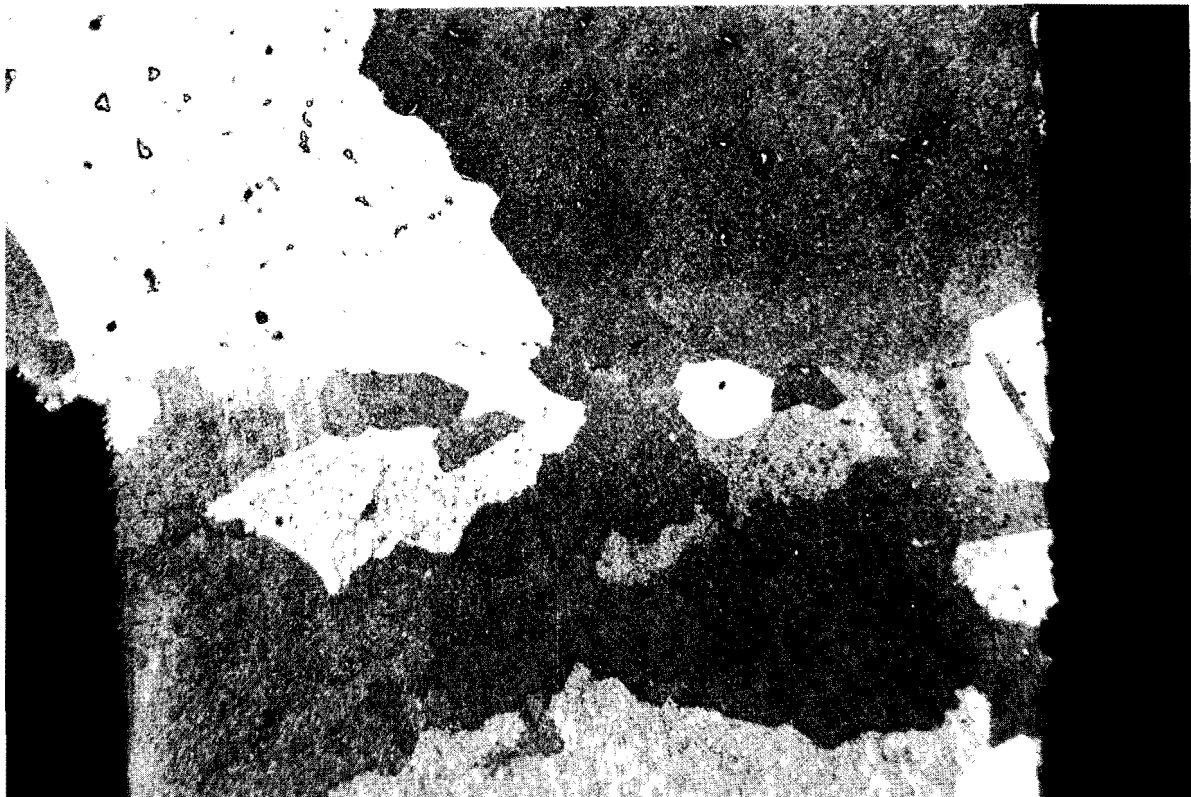
Figure 15. ADB Joint Between Tip Cap (Upper) and Airfoil Wall (Lower) After Diffusion Heat Treatment
